ANNUAL REPORT FOR 2009

Shoe Heel Creek Mitigation Site Robeson County TIP No. B-4248

Prepared By:
Natural Environment Unit & Roadside Environmental Unit
North Carolina Department of Transportation
June 2009

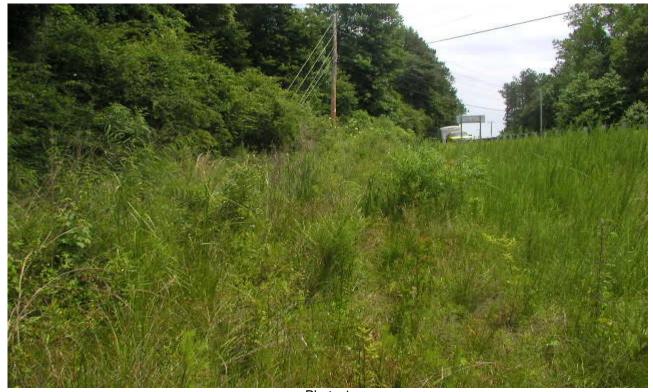
Photo 1

A portion of the site was inadvertently mowed after completing last year's monitoring. This portion was replanted on February 2, 2009. The impacted area where the old existing roadway fill was removed and revegetated is re-attaining wetland jurisdictional status and the planted species are surviving.
